IMECE2024-145303

## DAMAGE DETECTION AND IMAGING FOR COMPOSITE STORAGE TANKS UTILIZING ULTRASONIC GUIDED WAVES

### ABSTRACT

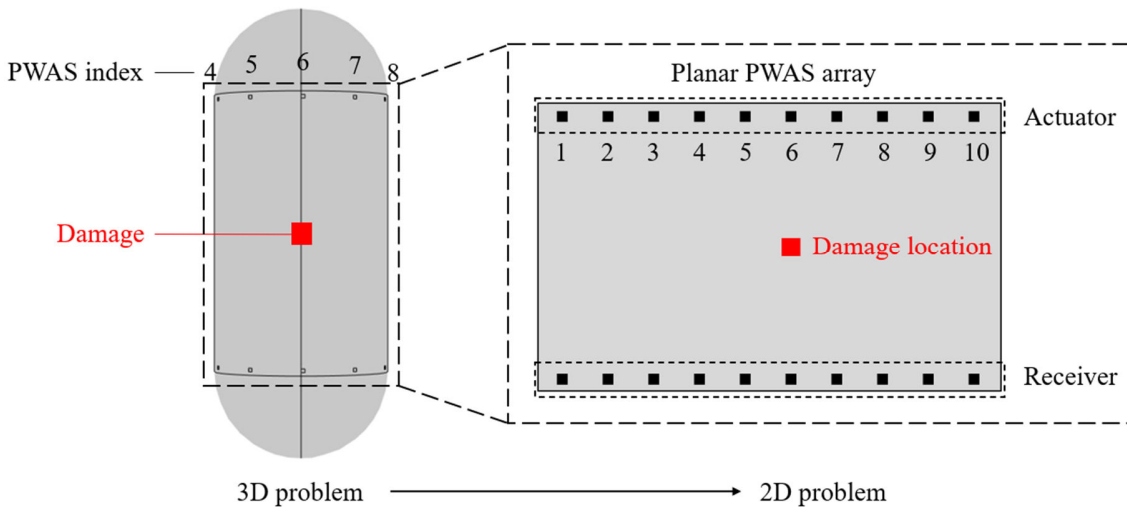
Based on the algorithm introduced in the previous section, we conducted localization and imaging of single and multiple damages on the numerical model. Initially, 10 PWAS were placed on both ends of the model's surface to form two arrays, used for signal excitation and reception. Due to the difficulty of applying the algorithm and performing imaging on curved surface models, the region of interest was unfolded along the edge between PWAS 1 and 10 to form a rectangle, simplifying the three-dimensional problem into a two-dimensional one according to Figure 3. It ensures both the simplicity and accuracy of damage localization and imaging in the study, thereby facilitating effective analysis.

**FIGURE 3:** DEMONSTRATION OF PROBLEM SIMPLIFICATION FROM 3D TO 2D UNDER THE CONDITION OF SINGLE DAMAGE

Focusing on the simulation conditions for single damage, the red square in Figure 3 represents the location of the damage, precisely between excitation and reception PWAS 6. To achieve localization and imaging of this damage, each excitation PWAS from 1 to 10 was actuated sequentially, and the PWAS array at the receiving end collected signals during excitation from each sensor, thus obtaining the SDI values for the entire region of interest and inferring the location of the damage. For example, Figure 4 illustrates the receiving signals from the PWAS array at the receiving end under excitation from PWAS 6. Consistent with theoretical expectations, apart from the receiving signal from PWAS 6, the signals received by the other PWASs remain unchanged compared to the pristine condition. However, a significant variation is observed in the receiving signal from PWAS 6, characterized by a decrease in signal amplitude and delayed time of flight, indicating the presence of damage along this path. Thus, both amplitude and flight time can be served as criteria for determining the location of damage. Therefore, final

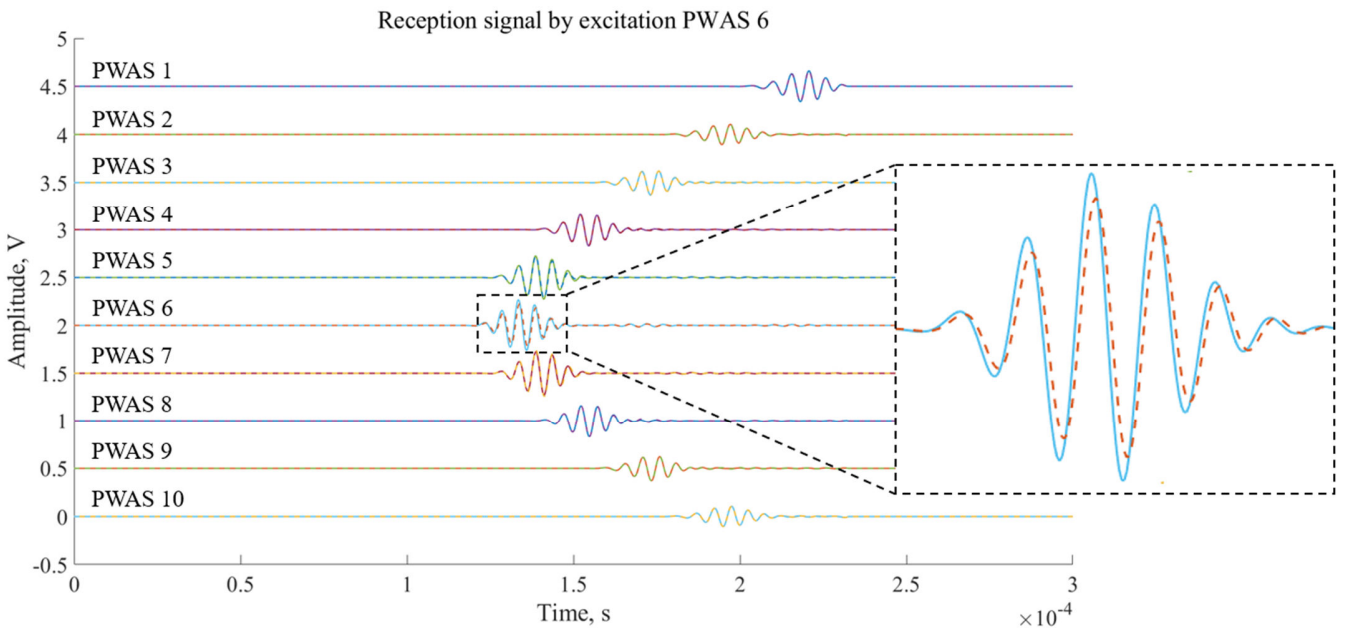
**FIGURE 4:** RECEPTION SIGNAL ILLUSTRATION BY EXCITATION PWAS 6 AND CHARACTERISTIC VALUES CAPTURE
